DRAFT - OMAE2014-23095 - LESSONS LEARNED FROM NORWEGIAN ANCHOR LINE FAILURES 2010-2013

Arne Kvitrud

Petroleum Safety Authority Norway (PSA)
Professor Olav Hanssens vei 10
NO-4003 Stavanger, Norway

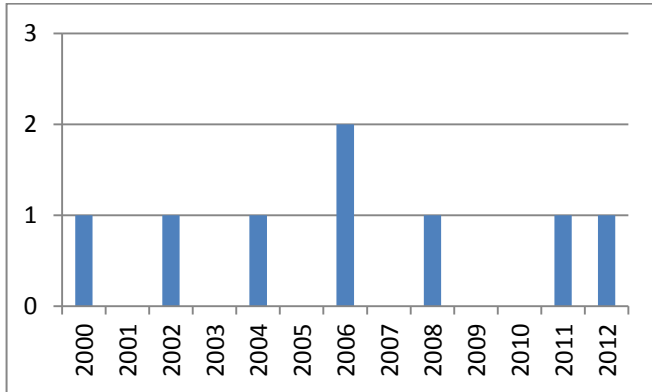
Figure 1: Cases with two or three line failures in the period 2000-2012 on the NSC. The cases are failures of lines, pay out from the winch, or significant dragging in combination with a line failure.
