**Anchor line failures
Norwegian continental shelf
2010-2014**

Rapporttittel Anchor line failures- Norwegian Continental Shelf - 2010-2014	Rapportnummer 992081
---	-------------------------

Organisasjonsenhet F-konstruksjonssikkerhet	Godkjent av Bjørn Thomas Bache
Forfatter/saksbehandler Arne Kvitrud	Dato 21.8.2014

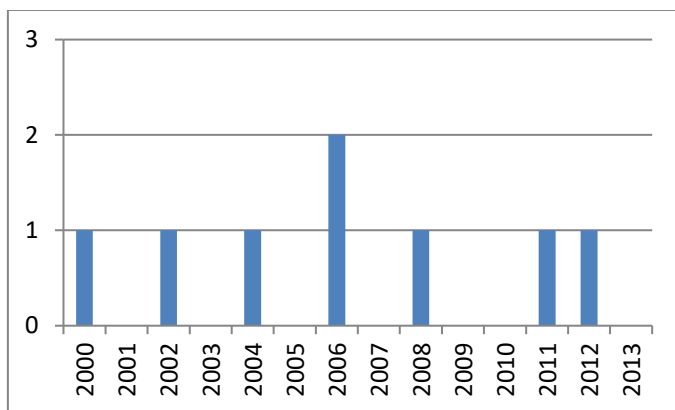
The cases with two or three line failure in Figure 1 are:

- 13.06.2000 *Bideford Dolphin*. Described briefly above.
- 24.12.2002 *Scarabeo 6*. One anchor dragged, caused the second to be torn off.
- 14.12.2004 *Ocean Vanguard*. Described briefly above.
- 24.11.2006 *Borgland Dolphin*. Two lines payed out.
- 31.10.2006 *Bideford Dolphin*. A chain failed due to fatigue, followed by another line paying out.
- 23.12.2008 *Scarabeo 5*. Two lines failed. Possible cause was loss of anchor, anchor dragging and line failure.
- 20.6.2011 *Navion Saga*. Described in detail above.
- 25.1.2012 *COSLPioneer*. Described in detail above.

Figure 1: Number of cases with two or three line failures in the period 2000-2012 on the NCS. The cases are related to failures of lines, pay out from the winch, or significant dragging in combination with a line failure.

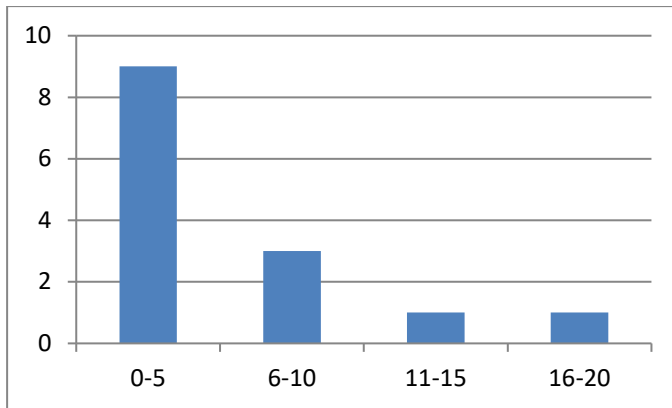
Figure 2: Number of failures as function of the age of the failed elements. The two double line failures are counted as one failure case.
