**Proceedings of the ASME 2018 37th International Conference on
Ocean, Offshore and Arctic Engineering
OMAE2018
June 17-22, 2018, Madrid, Spain**

OMAE2018-77008

OBSERVED WAVE ACTIONS ON NORWEGIAN SEMI-SUBMERSIBLE AND TLP DECKS

Arne Kvitrud

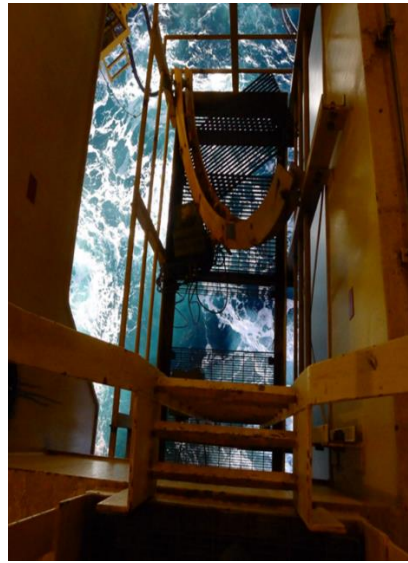
FIGURE 1: THE GAP IN THE GRATING ON THE BOP CARRIER PLATFORM WHICH THE PERSON FELL THROUGH ON SCARABEO 8 (PSA, 2015).

20 February 2015 a man fell overboard from Scarabeo 8. At the time of the incident, two engineers were working in the moonpool area. One of the engineers descended the ladder to a small access platform. As he stepped off the ladder onto the grating below, he fell through a gap directly into the sea 13.5m below. The man was rescued, without serious physical injuries. The exact moment when the grating disappeared is uncertain. The site of this incident is unlikely to have been in use since 6 February 2015. Scarabeo 8 was exposed to rough weather in the two weeks leading up to the incident (Eni, 16.3.2015 and PSA, 14.4.2015).
